# ANNUAL INSPECTION REPORT NEARMAN CREEK BOTTOM ASH IMPOUNDMENT

Kansas City, Kansas

B&V PROJECT NO. 190719

18 JANUARY 2017

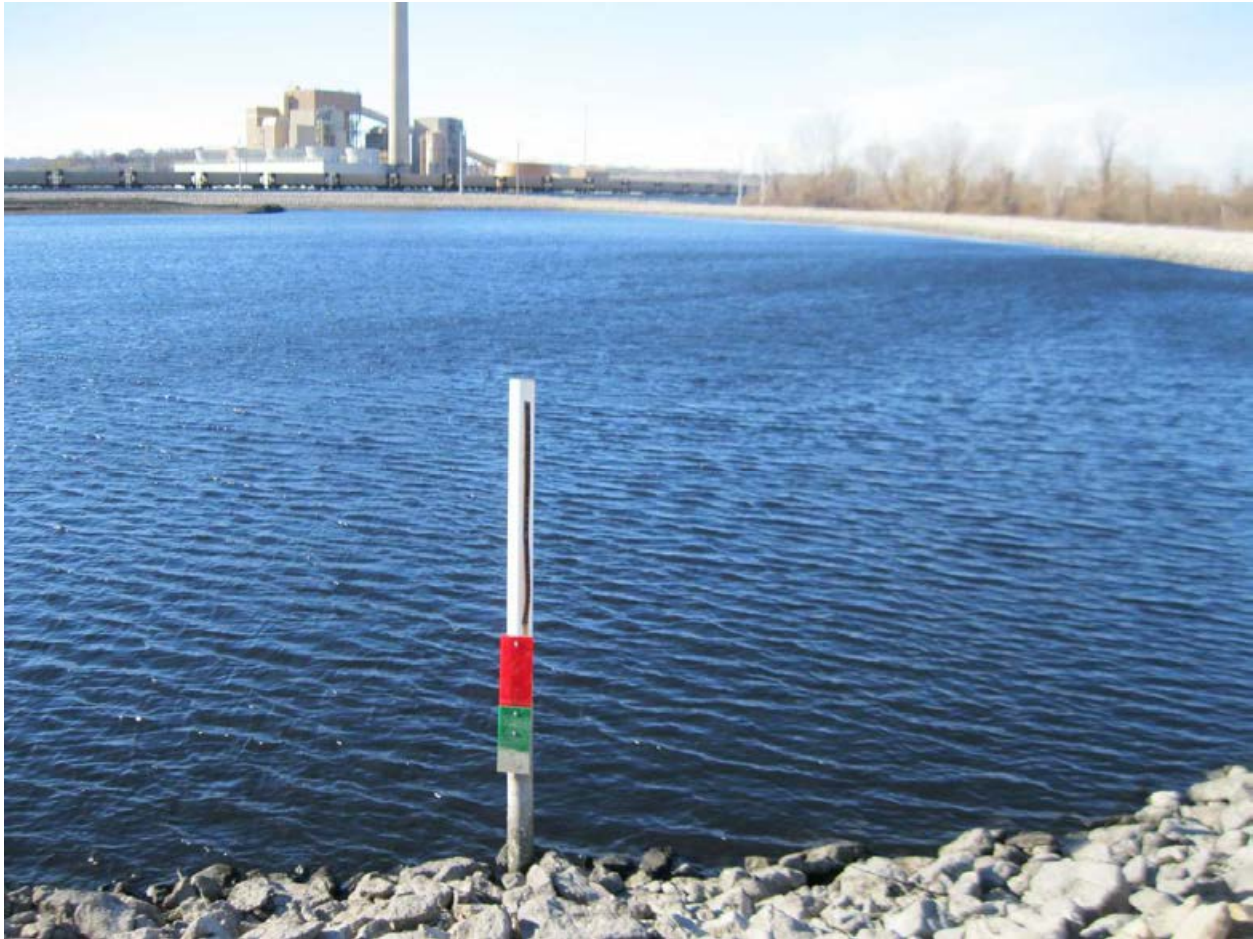
Figure 3-1 Water Level Indicator

There is a level indicator on the interior slope near the conduit between the ponds. The water level indicators are set to Elevation 760.59 feet at the top of the red marker, 759.55 feet at the top of the green marker and 758.49 feet at the bottom of the green marker. The approximate water elevation in the pond at the time of the inspection was Elevation 757.0 feet.

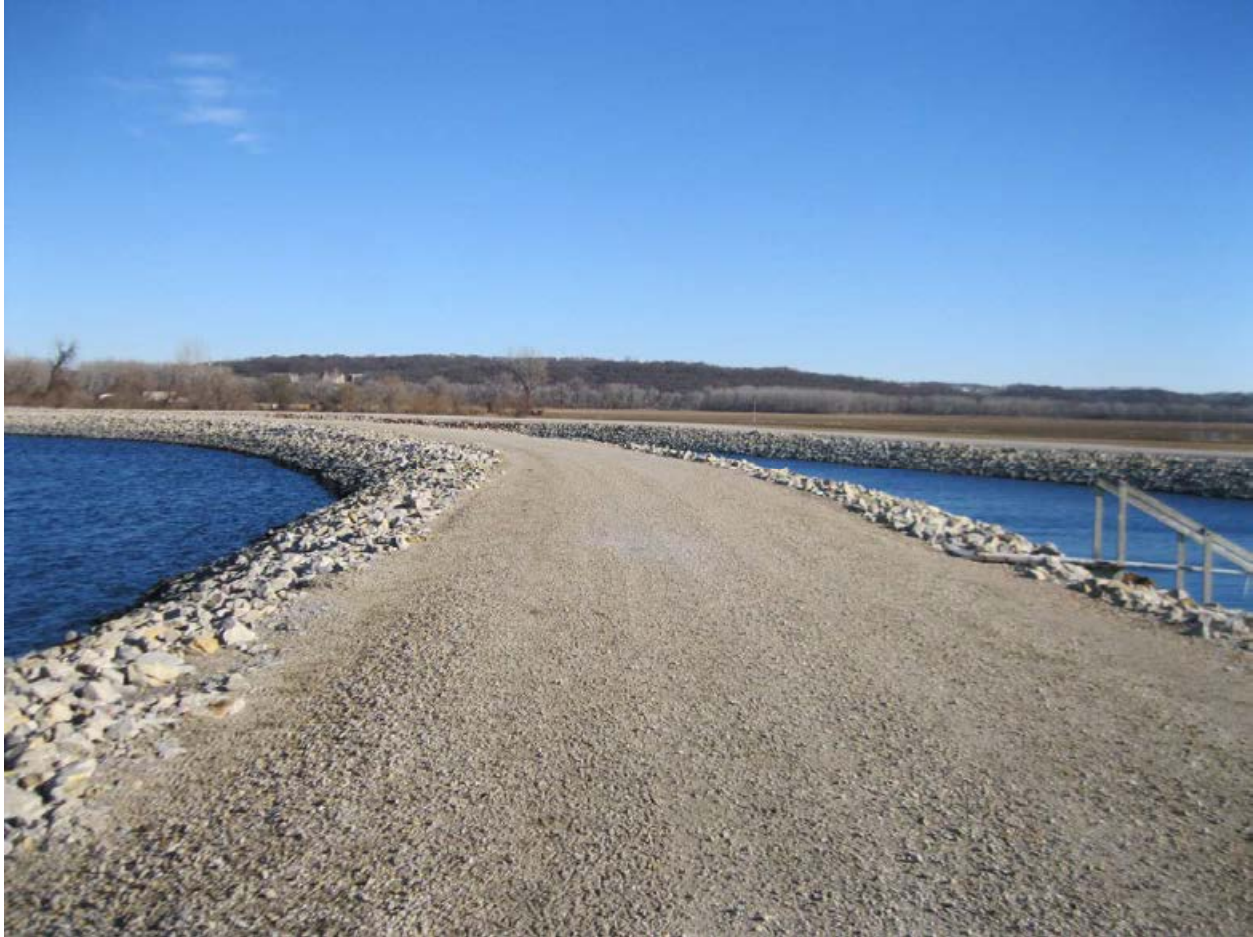
Figure 4-1 Interior Dike Crest Condition

The interior and exterior dike crest surfaces are covered with gravel road base material. The crest of the dikes appeared to be in good condition (Figure 4-1). No signs of cracking, settlement, movement, erosion or deterioration were observed during the assessment.

No vegetation was observed along the crest. The KCBPU staff indicated that vegetation has been periodically sprayed as part of the landscape maintenance and dead vegetation was observed.

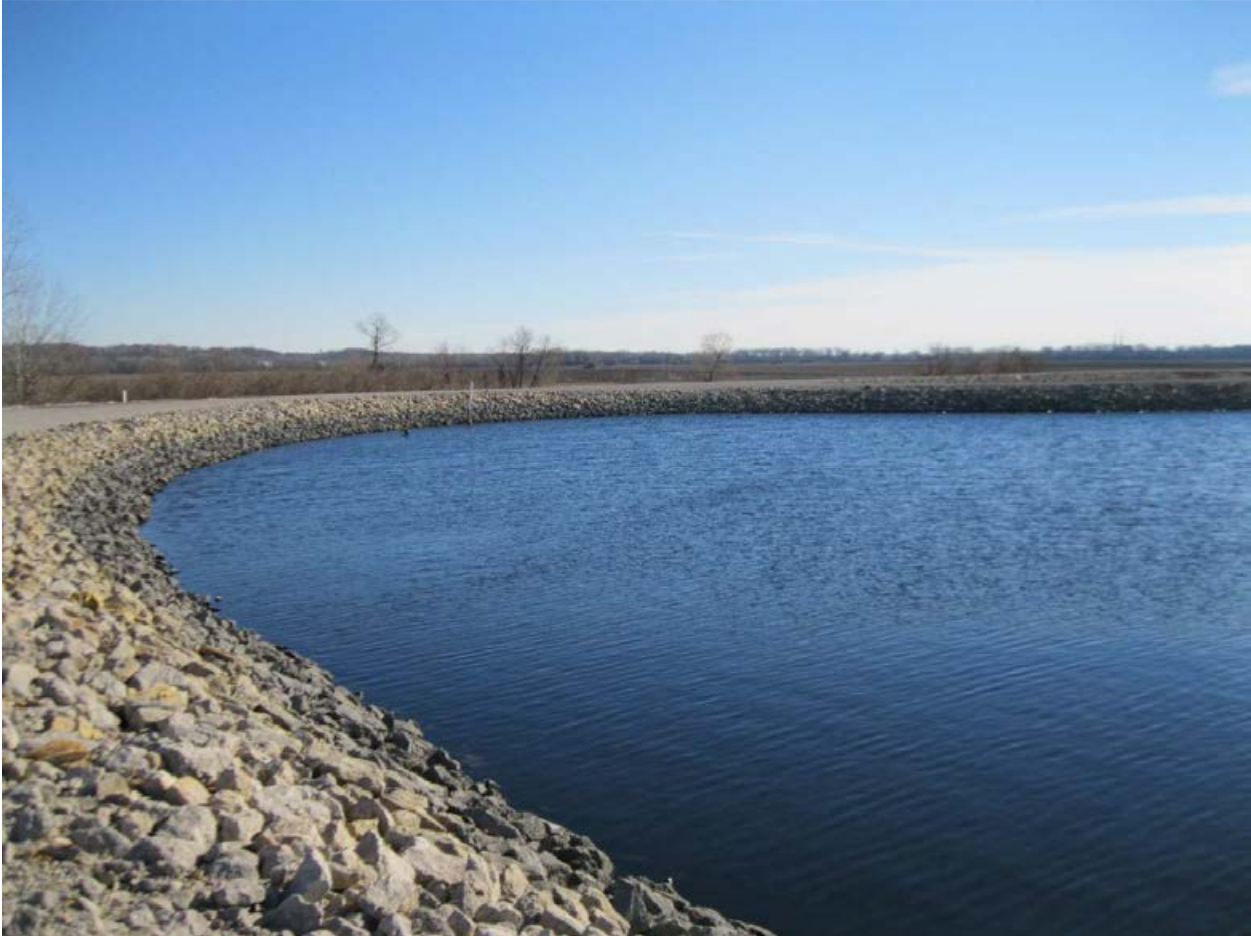
**Figure 4-2 Bottom Ash Pond Interior Slope Conditions**

The interior slopes of the bottom ash and clear water pond dikes are protected by riprap and appeared to be in excellent condition (Figure 4-2). There were no signs of erosion or surface instability. No vegetation was observed within the slopes. Water level has been reduced due to the ongoing construction and reduced power generation. The previous water levels could be observed as the darker riprap materials.

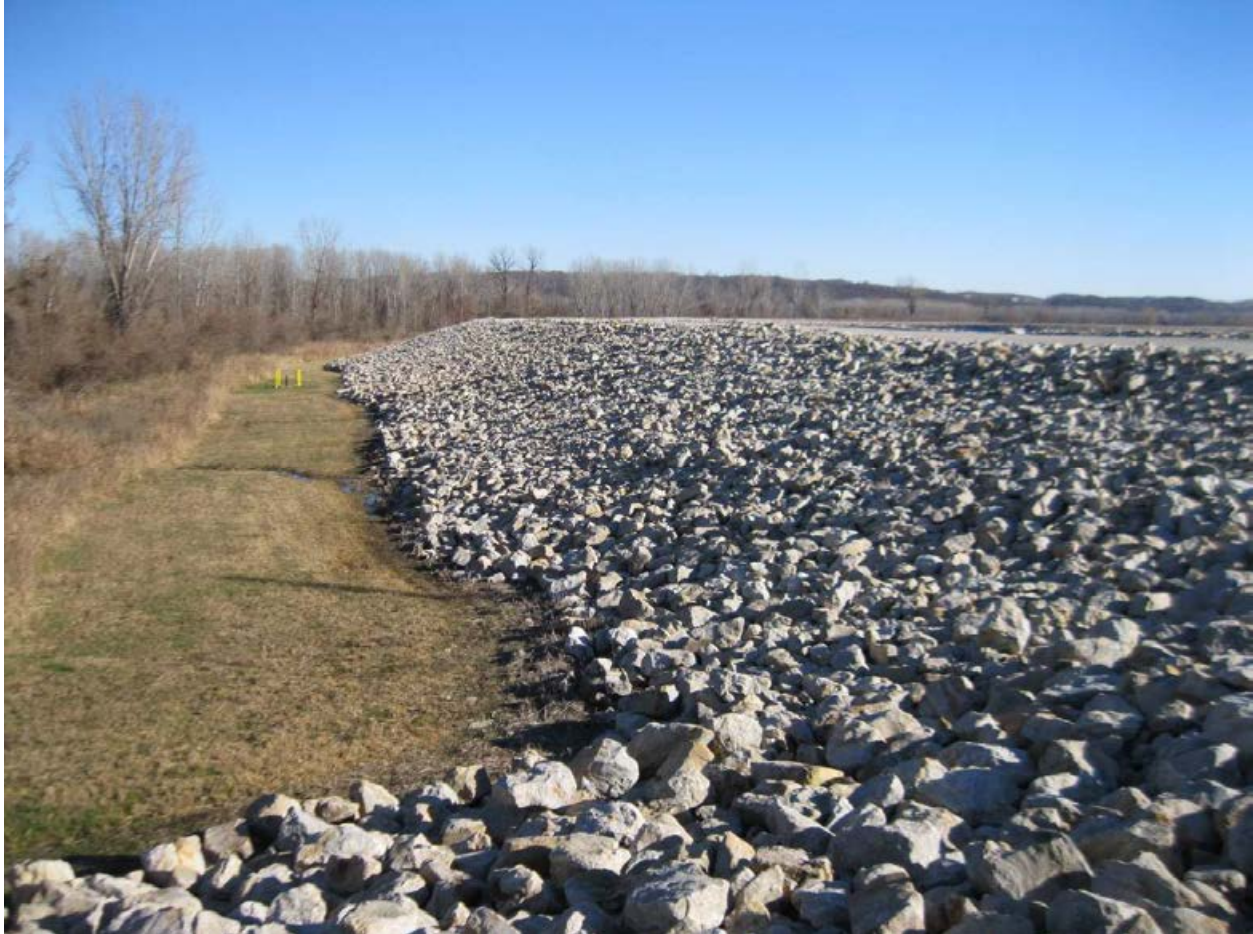
Figure 4-3 Exterior Dike Slope in North Facing Slope of Impoundment

In the northern portion of the impoundment, the exterior dike slope surface is covered with large riprap and appears to be in excellent condition (Figure 4-3). There were no indications of slumping or instability observed on this portion of the impoundment. No vegetation was noted within the riprap. The maintenance program includes periodic spraying of vegetation.

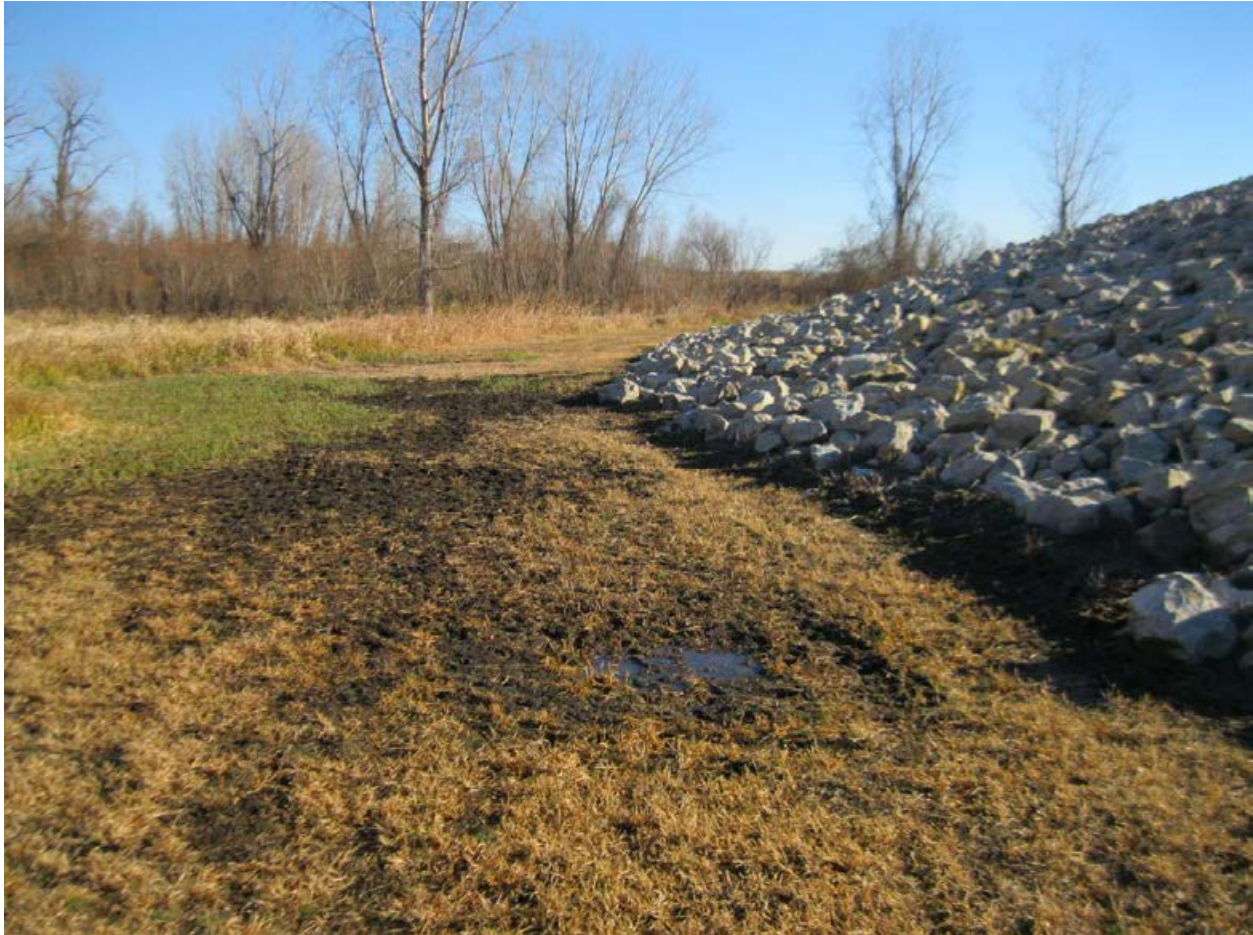
**Figure 4-4 Standing Water along Toe of North Facing Slope**

At the time of the inspection, standing water was noted at the toe of portions of the north facing slope (Figure 4-4). The standing water was clear with no indications of sediment or seepage issues at this location. This is the lowest grade along the toe and collects surface water runoff from the areas beyond the embankment.

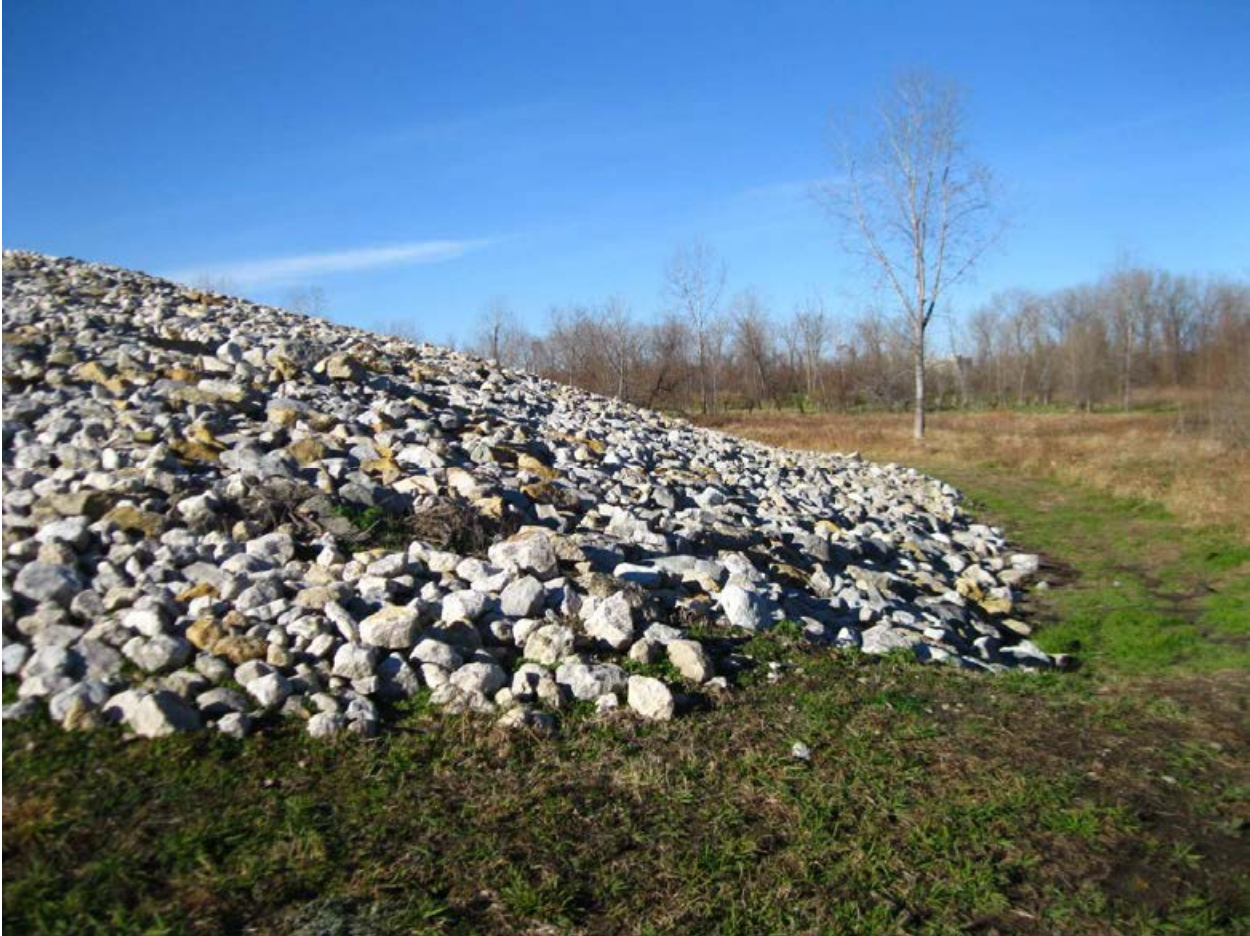
Figure 4-5 Exterior Dike Recent Riprap Placement.

During the previous annual inspection, the north riprap has ended near the outlet structure. The outlet structure had been plugged, but the riprap around the structure was in poor condition. During the year, riprap had been placed around the plugged outlet and extended to meet the east embankment (Figure 4-5). The riprap placement had been spread evenly along the face of the slope and was composed of intact limestone cobbles and boulders with little to no shale seams. (Figure 4-6).

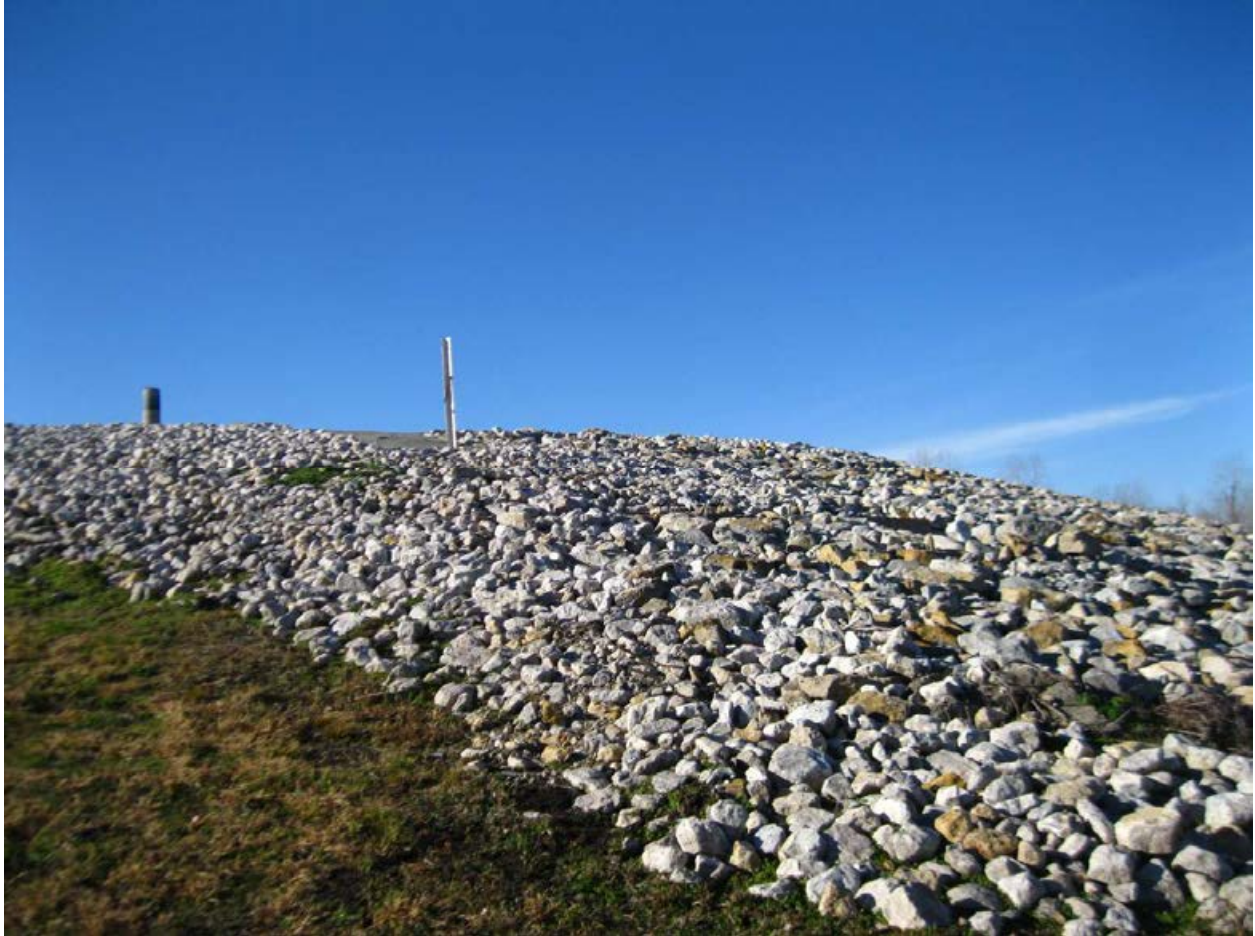
**Figure 4-6 Exterior Dike Slope Surface East of the Plugged Discharge Pipe.**

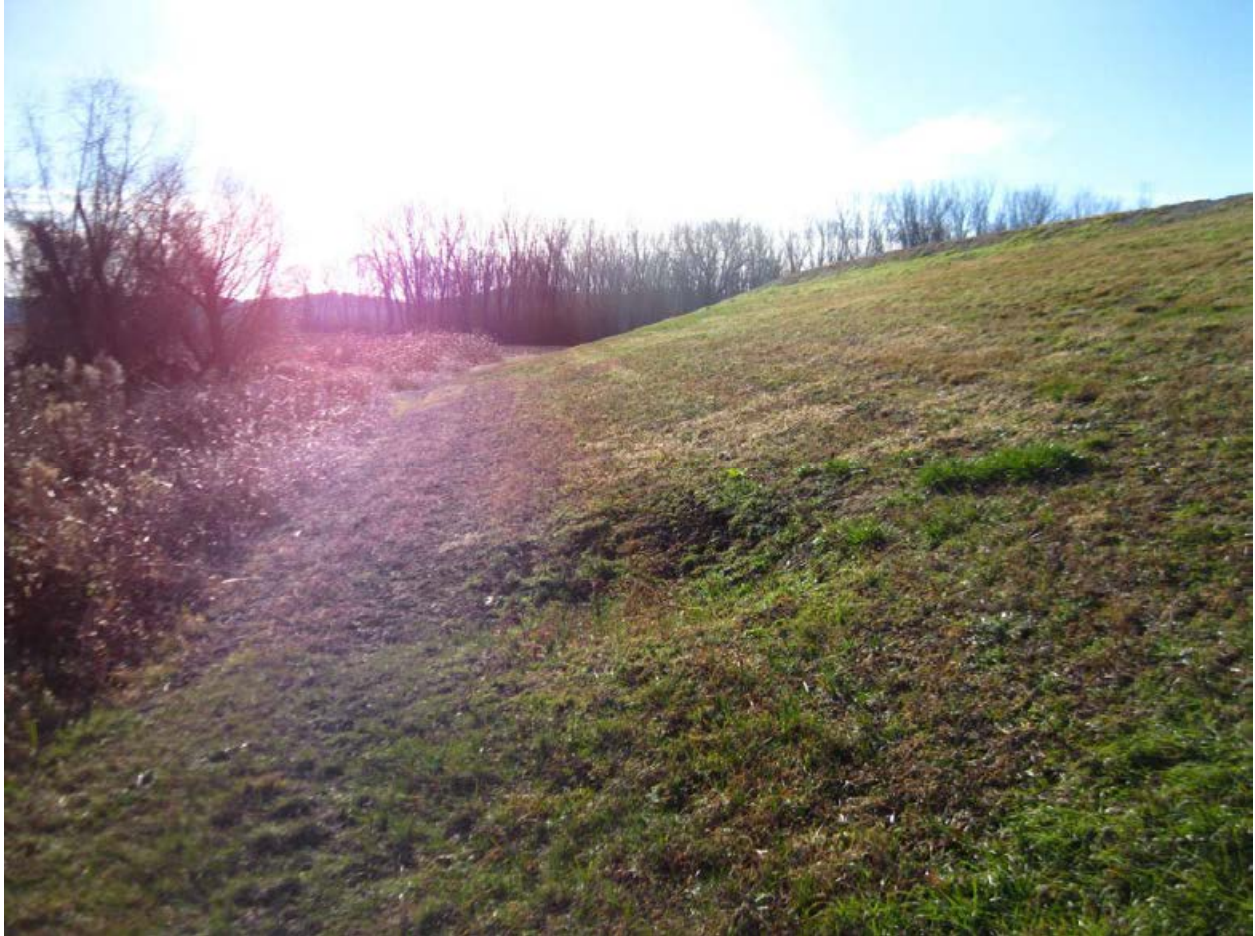
Along the east facing slope, there did appear to be some minor surface irregularities (Figure 4-7)

**Figure 4-7 Minor Surface Irregularity Along East Facing Exterior Slope.**

As shown in Figure 4-7, these surface irregularities appears as very low profile depressions on the slope with a height of generally less than 6 inches and diameter of approximately 3 feet. Three surface depressions were noted within the toe of the east facing exterior slope. The depressions did not appear to suggest any issues with seepage or surface instability. The depressions had been mowed and there was no rutting to indicate seepage issues.

Along the east facing exterior slope, the minor surface irregularities and depressions should be regraded and seeded.

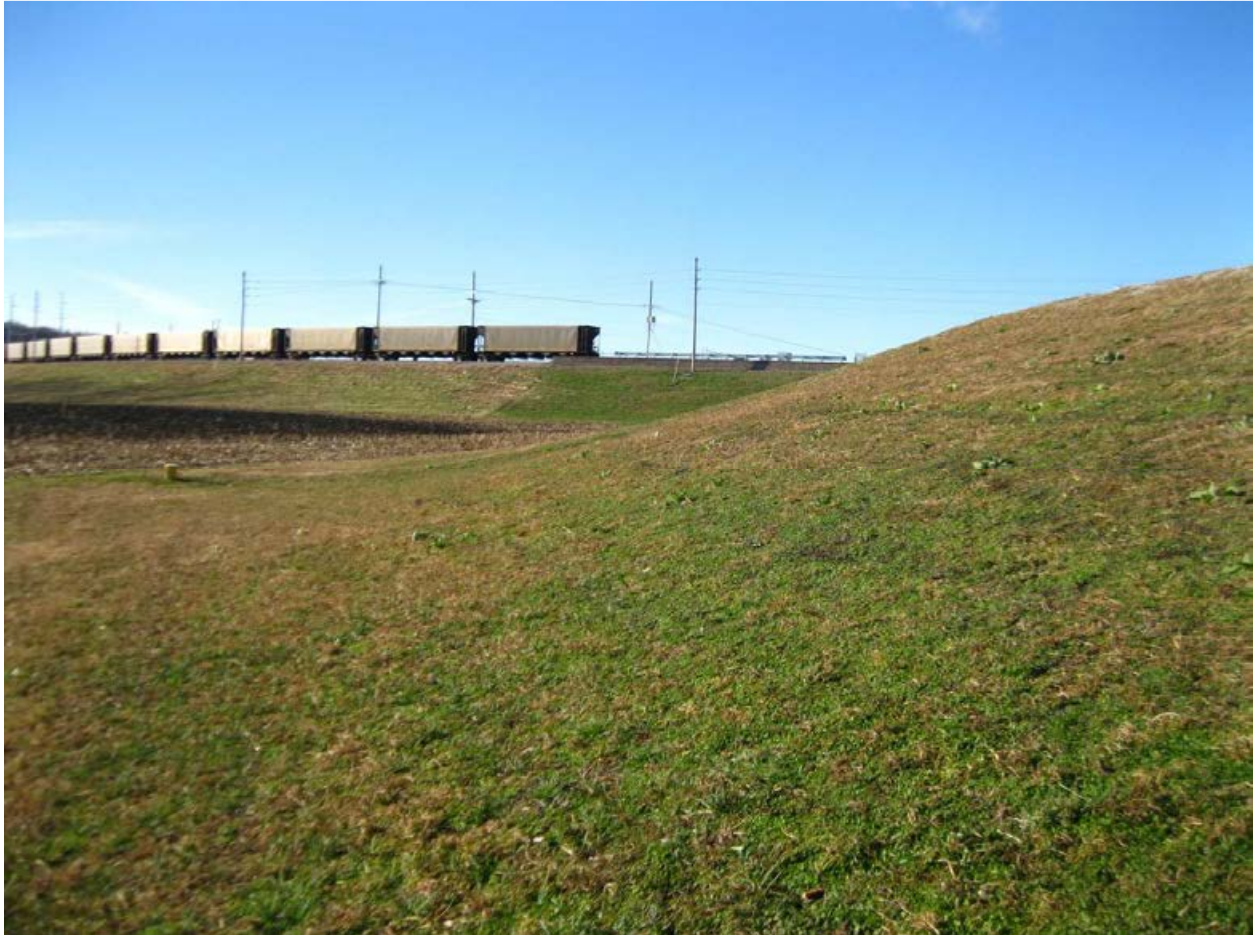
There were fewer observed animal burrows than the previous annual inspection. The BPU personnel stated they have trapped several moles along the south and east slopes and animal removal is now part of the maintenance plan. (Figure 4-8). KCBPU has contracted the United States Department of Agriculture (USDA) Animal and Plant Health Inspection Service (APHIS) to handle any animal issues associated with the Bottom Ash Pond.

**Figure 4-8 Minor Surface Disturbances Along the Southeast Facing Exterior Slope.**

The maintenance plan should continue to include the spraying of vegetation within the riprap and removal of burrowing animals.

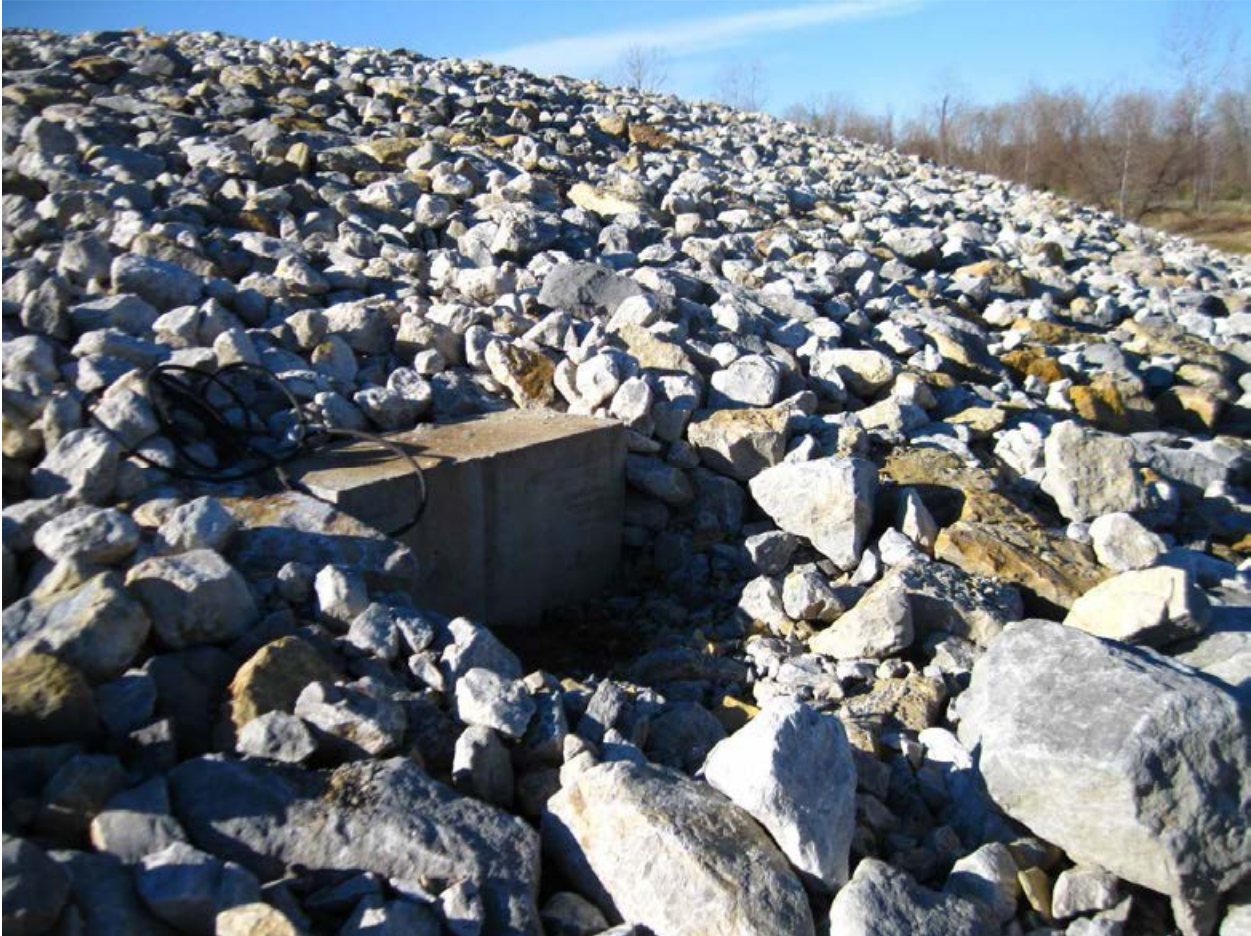
Only the 30 inch diameter plugged discharge pipe for the bottom ash pond was visible for inspection. This discharge pipe has been permanently sealed with concrete as shown in Figure 4-9. There were no signs of seepage or structural instability. The new riprap has been placed around the structure and was removed from the area directly below the outlet to maintain observations of the plug.

**Figure 4-9 Bottom Ash Pond 30 Inch Diameter Plugged Discharge Pipe.**

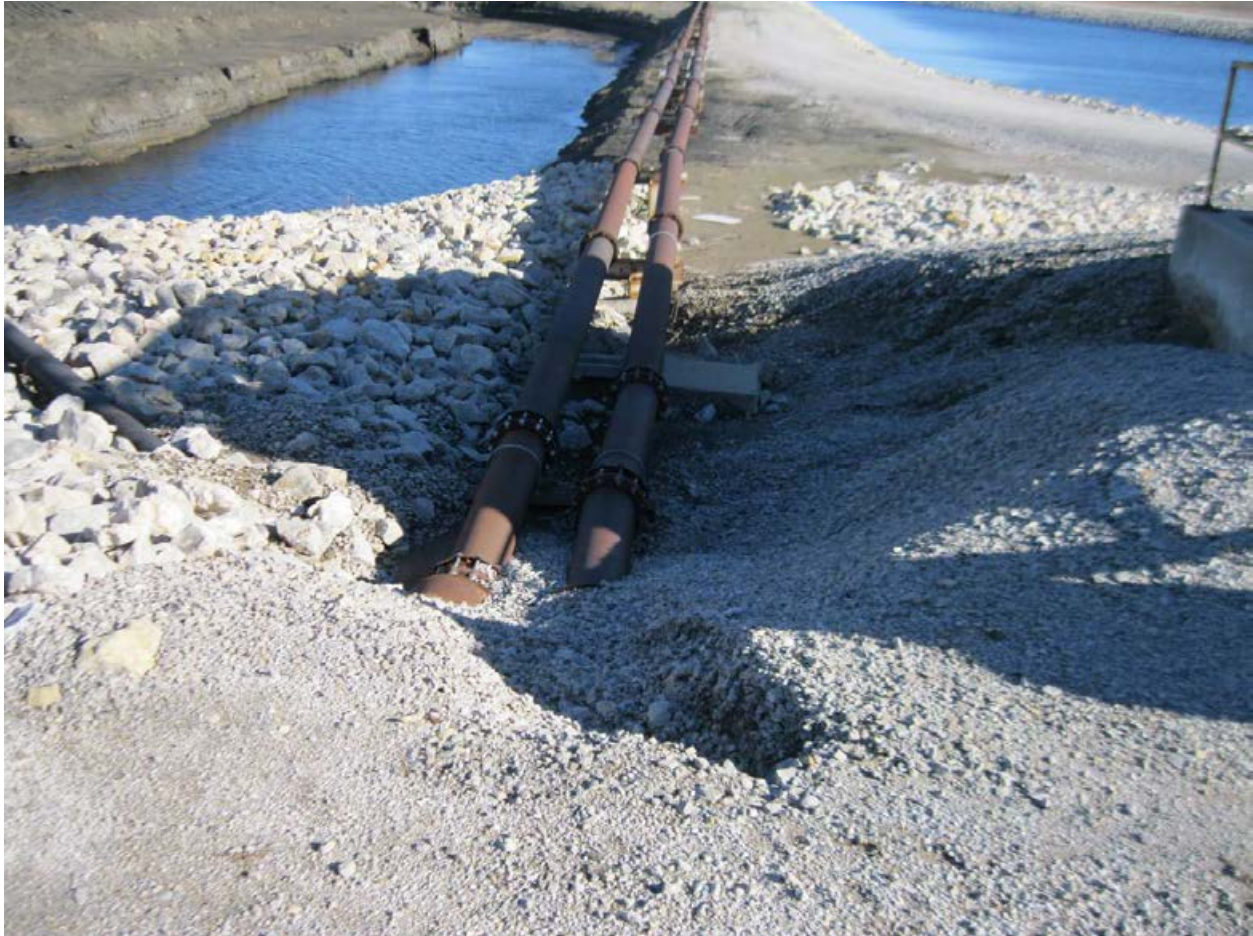
Additional structures observed during the inspection included the clear water pump house and bottom ash sluice pipes. A visual inspection of the exterior of the pump house indicated that the pump house was in good condition. The KCBPU staff indicated that the monthly equipment inspection of the sluicing system includes confirming the operation of the pump and gauges. The two bottom ash sluice pipes were also visually inspected and found to be in good working order. Minor erosion was noted where the sluice pipes pass beneath the plant access roads to the south of the impoundment (Figure 4-10).

**Figure 4-10 Minor Erosion Along Bottom Ash Sluice Pipes**

The erosion along the bottom ash discharge lines should be repaired to prevent further erosion of the plant access road.
